## FIELD FLOOR IMPACT INSULATION TEST REPORT

**U1509, 12 CUNNINGHAM STREET, NEWSTEAD**

**TITLE** Field Floor Impact Insulation Test  
U1509, 12 Cunningham Street, Newstead,  
QLD 4006  
Test Report

**TEST LOCATION** Level 15 U1509 Living area to Level 14 U1409 Living area

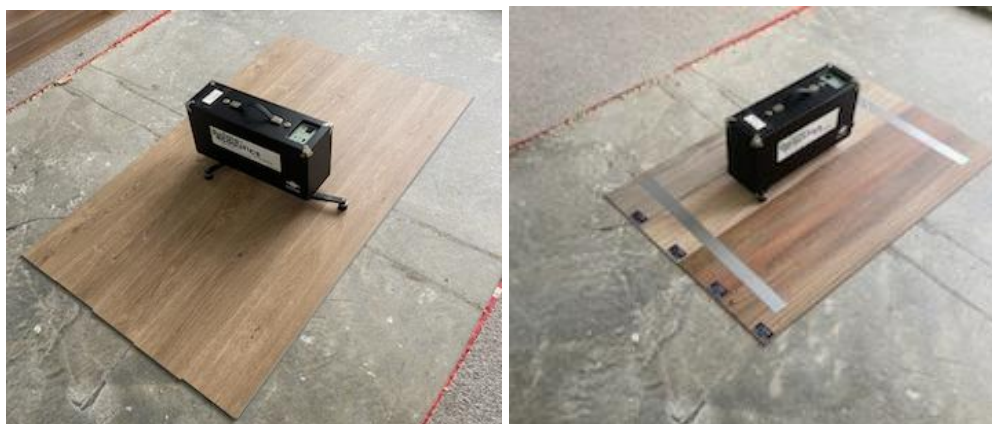
**Figure 1:** Testing at U1509, 12 Cunningham Street, Newstead.

Walls: Plasterboard;  
Floor: 200mm Concrete slab with Carpet and test sample;  
Room finish: Furnished.

Slab: 200mm Concrete;  
Walls: Plasterboard;  
Ceiling: Suspended Plasterboard;  
Floor: Carpet/Tiles;  
Room finish: Furnished.

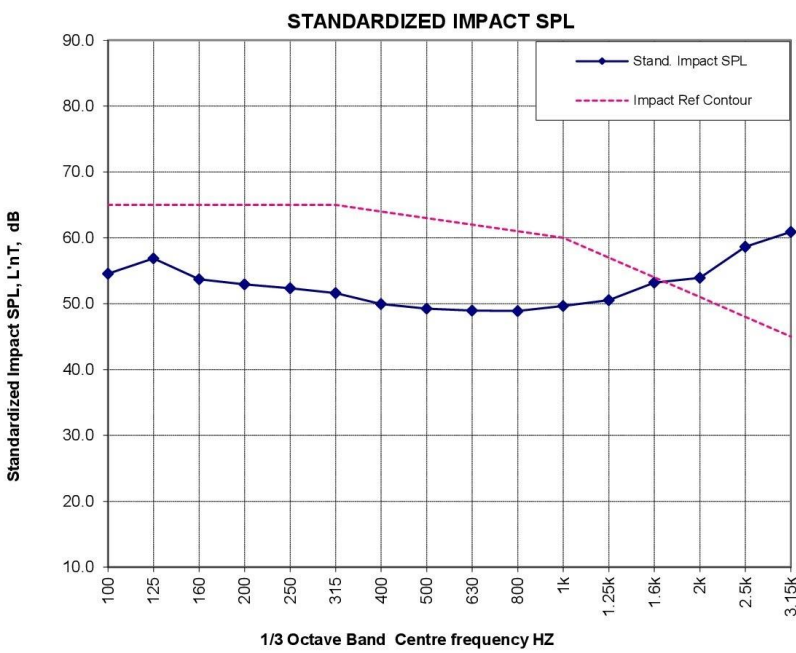
Test 1 - Bare slab

Acoustics and Audio Visual - Consulting Engineers		Member Firm: AAAC Association of Australasian Acoustical Consultants																																																																													
<b>FIELD IMPACT SOUND INSULATION - TEST CERTIFICATE</b>																																																																															
		Test 1 of 3																																																																													
<b>200mm Bare Concrete Slab</b>																																																																															
<b>PROJECT:</b> PN5835 U1509 Cunningham Street, Newstead <b>Test Location:</b> Level 15 U1509 Living to Level 14 U1409 Living <b>Client:</b> Flooring Distributors of Australia (FDA) <b>Test Performed:</b> Eric Huang		<b>Meas. Date:</b> 12-Jun-2023 <b>Meas. Parameter:</b> LLeq <b>Tapping Machine:</b> B&K, Type 3207 <b>Receiving Room Volume:</b> 103 m <sup>3</sup>																																																																													
<b>DESCRIPTION OF FLOOR AND SPECIMEN</b>		<b>No. of Source posn:</b> 2																																																																													
Test Surface: 200mm Bare Concrete Slab		<b>Mic. posn:</b> 2 sweeps																																																																													
Underlay:		<b>RT meas:</b> 6 Imp.																																																																													
Adhesive:		<b>SLM:</b> Nor 140																																																																													
Ceiling: Suspended plasterboard																																																																															
Slab: 200mm Concrete																																																																															
<b>Weighted Standardized Impact SPL</b>		<b>L'nT,w 63</b>																																																																													
Results standardized to a RT of 0.5 seconds		ISO 16283-2:2015 & 717-2:2013

Centre Frequency	Stand. Impact SPL	Impact Ref Contour	Deficiencies																																																																												
Hz	dB	dB	dB																																																																												
100	54.6	65																																																																													
125	56.9	65																																																																													
160	53.7	65																																																																													
200	52.9	65																																																																													
250	52.3	65																																																																													
315	51.6	65																																																																													
400	50.0	64																																																																													
500	49.2	63																																																																													
630	49.0	62																																																																													
800	48.9	61																																																																													
1k	49.7	60																																																																													
1.25k	50.5	57																																																																													
1.6k	53.2	54																																																																													
2k	53.9	51	2.9																																																																												
2.5k	58.7	48	10.7																																																																												
3.15k	60.9	45	15.9																																																																												
Total																																																																															
L'nT,w 63		29.5																																																																													
24 Mexicanus Drive Park Ridge QLD 4125 Ph (61 7) 3802 2155

Test System	L'nT,w
1.	200mm Bare Concrete slab – U1509 Living Area to U1409 Living Area	63
2.	Paramount Wood 5mm loose laid – U1509 Living Area to U1409 Living Area	53
3.	Paramount Wood 5mm + Regupol Sonus Multi 3mm – U1509 Living Area to U1409 Living Area	46

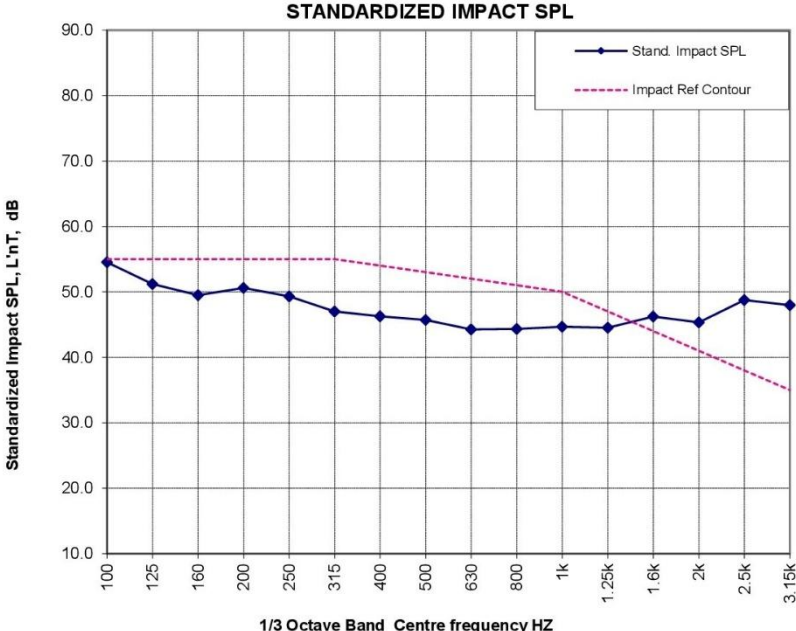
Test 6 - Paramount Wood 5mm loose laid

Member Firm: AAAC																																																																													
		Association of Australasian Acoustical Consultants																																																																													
<b>FIELD IMPACT SOUND INSULATION - TEST CERTIFICATE</b>																																																																															
		Test 2 of 3																																																																													
Paramount Wood 5mm loose laid																																																																															
PROJECT: PN5835 U1509 Cunningham Street, Newstead		Meas. Date: 12-Jun-2023																																																																													
Test Location: Level 15 U1509 Living to Level 14 U1409 Living		Meas. Parameter: LLeq																																																																													
Client: Flooring Distributors of Australia (FDA)		Tapping Machine: B&K, Type 3207																																																																													
Test Performed: Eric Huang		Receiving Room Volume: 103 m <sup>3</sup>																																																																													
DESCRIPTION OF FLOOR AND SPECIMEN		No. of Source posn: 2																																																																													
Test Surface: Paramount Wood 5mm loose laid		Mic. posn: 2 sweeps																																																																													
Underlay:		RT meas: 6 Imp.																																																																													
Adhesive: Loose laid		SLM: Nor 140																																																																													
Ceiling: Suspended plasterboard																																																																															
Slab: 200mm Concrete																																																																															
Weighted Standardized Impact SPL		L'nT,w 53																																																																													
Results standardized to a RT of 0.5 seconds		ISO 16283-2:2015 & 717-2:2013

Centre Frequency	Stand. Impact SPL	Impact Ref Contour	Deficiencies																																																																												
Hz	dB	dB	dB																																																																												
100	54.5	55																																																																													
125	< 51.2	55																																																																													
160	< 49.5	55																																																																													
200	50.6	55																																																																													
250	< 49.3	55																																																																													
315	< 47.0	55																																																																													
400	< 46.3	54																																																																													
500	< 45.7	53																																																																													
630	< 44.3	52																																																																													
800	< 44.3	51																																																																													
1k	< 44.7	50																																																																													
1.25k	< 44.5	47																																																																													
1.6k	< 46.2	44	2.2																																																																												
2k	< 45.4	41	4.4																																																																												
2.5k	48.8	38	10.8																																																																												
3.15k	48.0	35	13.0																																																																												
Total																																																																															
L'nT,w 53		30.3																																																																													
24 Mexicanus Drive Park Ridge QLD 4125

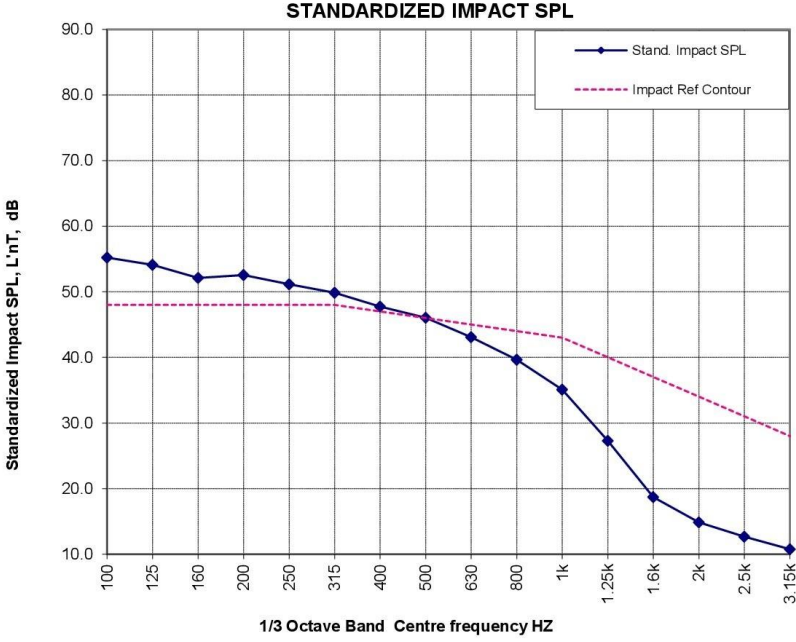
Test 7 - Paramount Wood 5mm + Regupol Souns Multi 3mm

Member Firm: AAAC Association of Australasian Acoustical Consultants																																																																													
<b>FIELD IMPACT SOUND INSULATION - TEST CERTIFICATE</b>																																																																															
		Test 3 of 3																																																																													
<b>Paramount Wood 5mm</b>		<b>Regupol Souns Multi 3mm</b>																																																																													
<b>PROJECT:</b> PN5835 U1509 Cunningham Street, Newstead <b>Test Location:</b> Level 15 U1509 Living to Level 14 U1409 Living <b>Client:</b> Flooring Distributors of Australia (FDA) <b>Test Performed:</b> Eric Huang		<b>Meas. Date:</b> 12-Jun-2023 <b>Meas. Parameter:</b> LLeq <b>Tapping Machine:</b> B&K, Type 3207 <b>Receiving Room Volume:</b> 103 m <sup>3</sup>																																																																													
<b>DESCRIPTION OF FLOOR AND SPECIMEN</b>		<b>No. of Source posn:</b> 2																																																																													
Test Surface: Paramount Wood 5mm		<b>Mic. posn:</b> 2 sweeps																																																																													
Underlay: Regupol Souns Multi 3mm		<b>RT meas:</b> 6 Imp.																																																																													
Adhesive: Loose laid		<b>SLM:</b> Nor 140																																																																													
Ceiling: Suspended plasterboard																																																																															
Slab: 200mm Concrete																																																																															
<b>Weighted Standardized Impact SPL</b>		<b>L'nT,w 46</b>																																																																													
Results standardized to a RT of 0.5 seconds		ISO 16283-2:2015 & 717-2:2013

Centre Frequency	Stand. Impact SPL	Impact Ref Contour	Deficiencies																																																																												
Hz	dB	dB	dB																																																																												
100	55.2	48	7.2																																																																												
125	54.1	48	6.1																																																																												
160	52.1	48	4.1																																																																												
200	52.6	48	4.6																																																																												
250	51.1	48	3.1																																																																												
315	49.9	48	1.9																																																																												
400	47.8	47	0.8																																																																												
500	46.0	46	0.0																																																																												
630	43.1	45																																																																													
800	39.6	44																																																																													
1k	35.1	43																																																																													
1.25k	27.3	40																																																																													
1.6k	< 18.7	37																																																																													
2k	< 14.9	34																																																																													
2.5k	< 12.7	31																																																																													
3.15k	< 10.8	28																																																																													
Total																																																																															
L'nT,w 46		27.8																																																																													
24 Mexicanus Drive Park Ridge QLD 4125 Ph (61 7) 3802 2155
